# SAFETY BULLETIN

# SB No.: **SD-1/012a**

Type:SPACEKModel:SD-1 Minisport of all versionsSerial Number:SN001-SN245, SN247Applicable countries:All countries

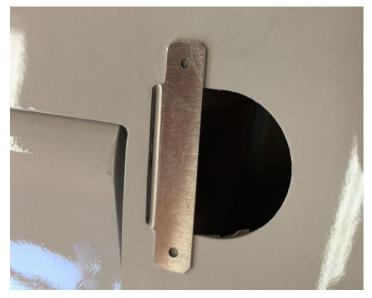
The stop in place before drilling:

- **1.** See drawing SD1-20-250 for reference.
- 2. Modify shape of hole in the bottom of wing tip for end bolt installation in accordance to drawing.
- 3. Fabricate and bend stops in accordance to drawing.
- 4. Drill installation holes to the wing tip thru stop. Install stop using prescribed HW.

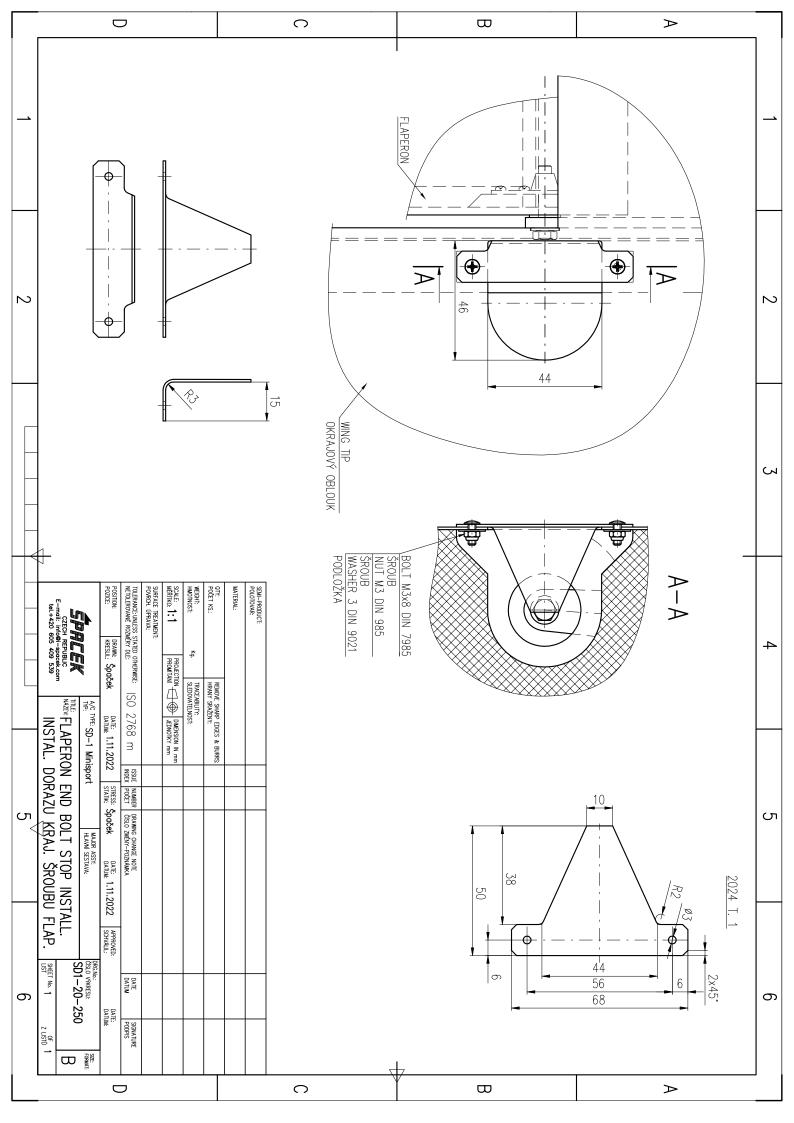
SD1-20-250

The inflight release of flaperon from the wing occurred on one SD-1 due to loss of middle and tip hinge bolts. Pilot has activated parachute rescue system and airplane descended safely into field.
